uptime[®]

dec/jan 17

RECIPROCATING PUMPS: System Modification for Maintenance IMPROVEMENT

by Victor C. Owunne, Dr. Jyoti K. Sinha
and Dr. Adrian D. Nembhard

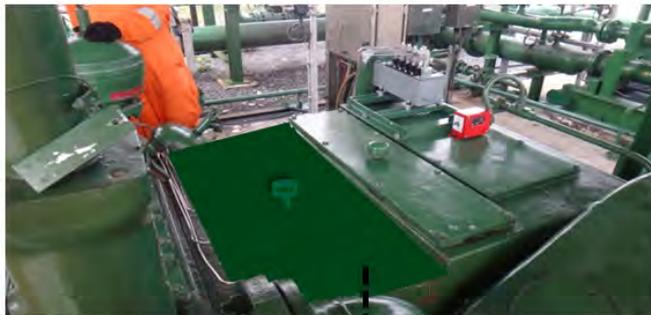
Figure 1: Spiking pump (SP) at the plant

A reciprocating pump in an oil and gas plant, referred to as a spiking pump (SP) in this article, was used in the transfer of condensate from a condensate tank into a gas pipeline (see Figure 1).
