The Role of MACHINERY

CASE ANALYSIS

PROTECTION SYSTEMS

By Allen Bailey

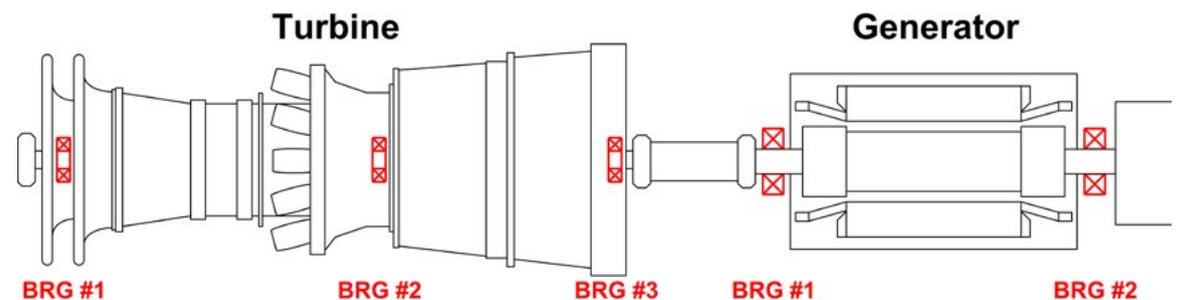
The machine train consisted of a GE Frame 7EA gas turbine with three oil film bearings directly coupled to a GE 91 MW generator (60 Hz) assembly with two oil film bearings. The facility was using a gas turbine control

Figure 1: Gas turbine / generator top view

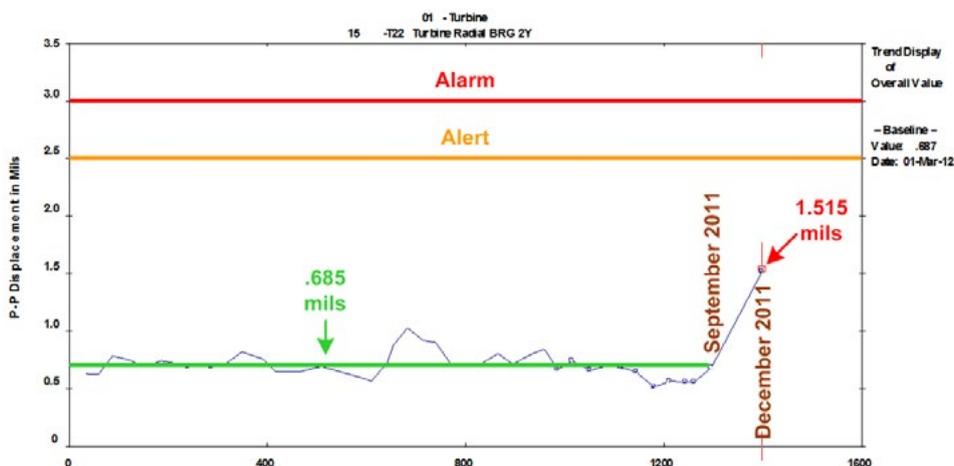
pk-pk and be in an **alarm** state if amplitudes were above 3 mils pk-pk. The historical vibration data showed amplitudes at this bearing position aver-

aging .685 mils pk-pk, with an increase to 1.515 mils pk-pk after being put back into service in December 2011.

Figure 2: Condition monitoring data, turbine bearing 2

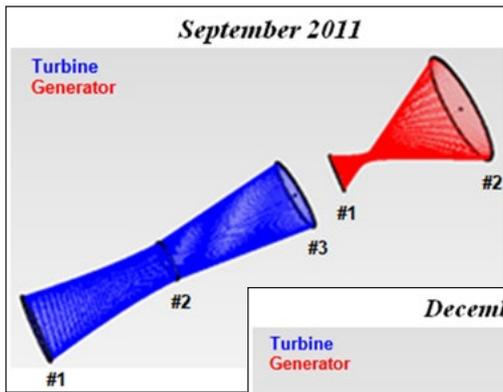
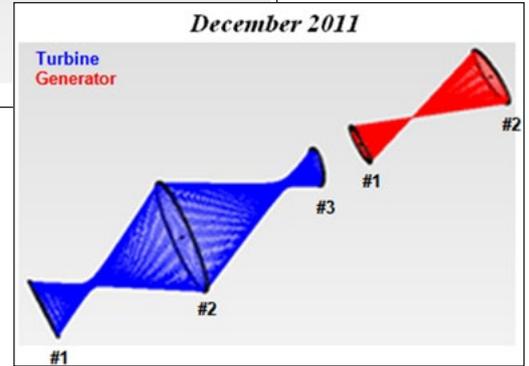
Peak and Phase ODS at 60 Hz

By reviewing the machine's archived data snapshots, technicians were able to produce orbit-based animations for comparative operating deflection shape (ODS) analysis that included all the radial proximity probe data. These comparisons allowed for common scaling of all the bearing positions monitored, resulting in a visual representation of the turbine and generator shaft vibration amplitudes and phase relationships. This ODS analysis clearly showed the #2 turbine bearing's relative increase in amplitude after the September 2011 major inspection and also indicated a phase relationship change across the turbine shaft.

Figure 3: Operating deflection shape comparison, turbine bearings

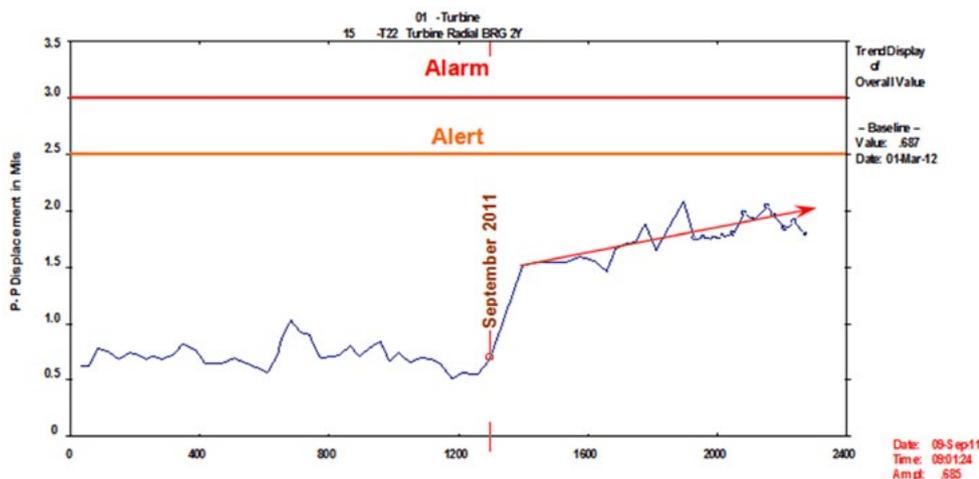
alarm levels, but is experiencing a slow increase in turbine #2's bearing vibration amplitudes. The ongoing monitoring of this machine (e.g., machinery protection system, route-based vibration analysis and multi-channel transient vibration testing) will be used to track the defect's severity over time to ultimately aid in determining if the next major inspection should be moved up to avoid a catastrophic failure of the turbine.

Figure 5: Condition monitoring data, turbine bearing 2

Due to the facility's projected run schedule and customer demand, it was determined that the machine's vibration amplitudes and signature shifts could not warrant a system shutdown to incorporate the repairs necessary for returning the turbine's bearing alignments back to within specification. By catching and isolating the cause for increased vibration levels in the #2 turbine bearing after the facility's initial start-up, the plant's reliability and maintenance departments were able to make accommodations for performing a precision bore alignment through the entire machine train at the next scheduled major inspection, which has a six to seven year periodicity.
